Checkmate Lifting & Safety Ltd.
New Rd. Sheerness, Kent ME12 1PZ. UK.
Tel: +44(0)1795 580333 Fax: +44(0)1795 668280
www.checkmateuk.com

HLL1 16mm Lifeline Inspection Manual

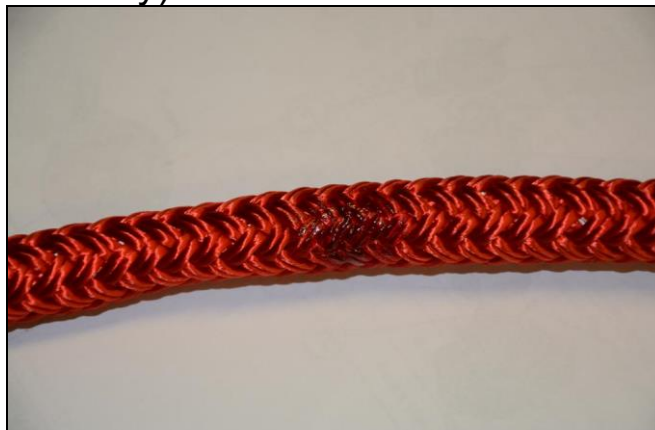
2.1 HEAT DAMAGE

Inspect the entire lifeline for signs of heat damage (See image below for clarity).

**Acceptable, service may continue.
If the damage is any greater than the
example given the lifeline must be
removed from service.**

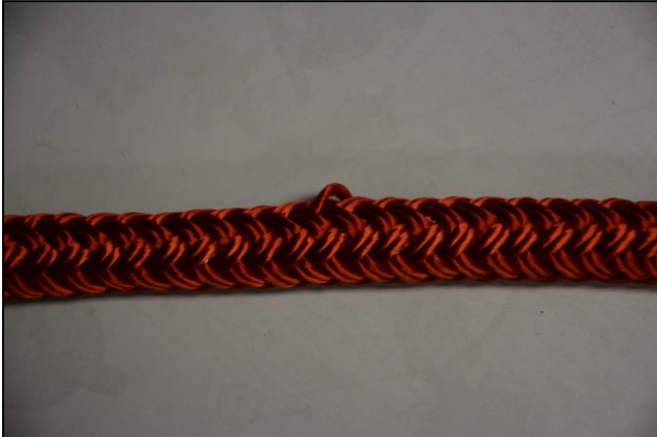
**Acceptable amount of damage,
service may continue.**

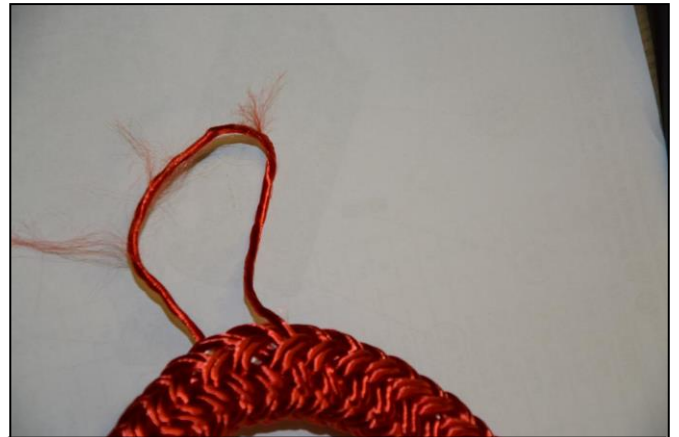
**Unacceptable amount of damage,
remove from service immediately.**

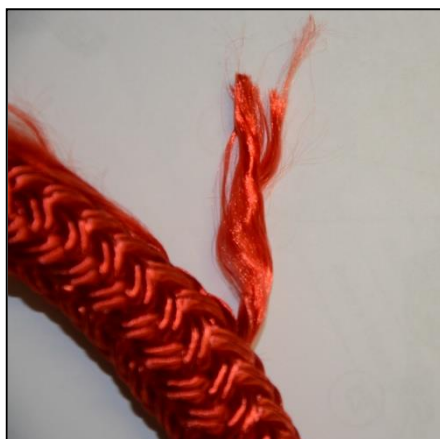
2.3 SEVERED STRANDS

Inspect the entire length of the lifeline for signs of severed strands such as the one shown below. If the lifeline looks as below remove from service immediately.

**Unacceptable amount of
damage, remove from
service immediately.**

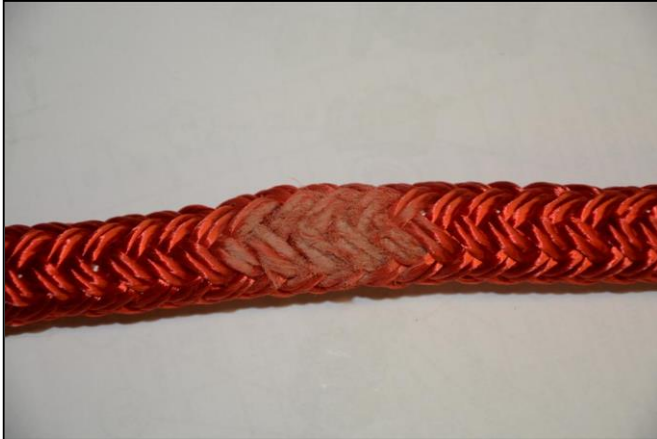
**Acceptable amount of damage,
service may continue.**

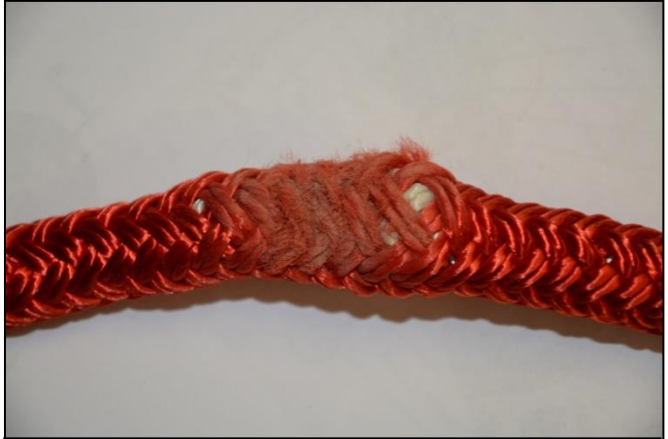
**Unacceptable amount of damage,
remove from service immediately.**

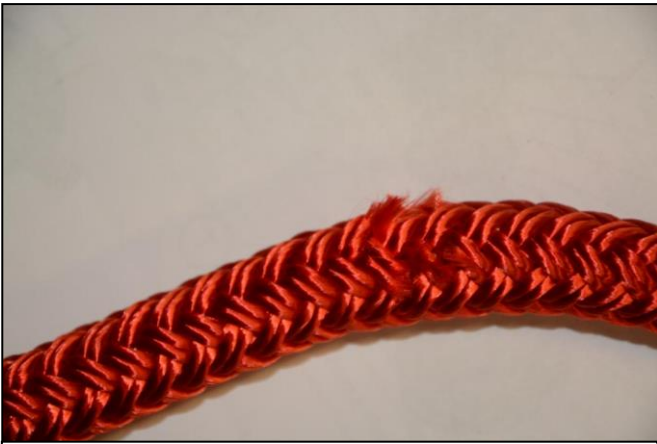
**Acceptable amount of damage,
service may continue.**

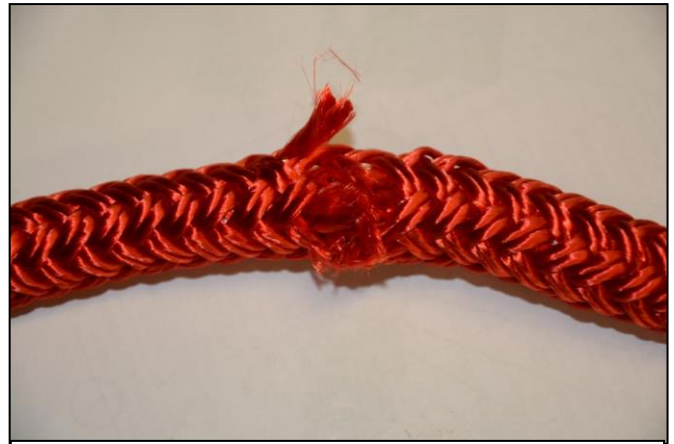
**Unacceptable amount of damage,
remove from service immediately.**

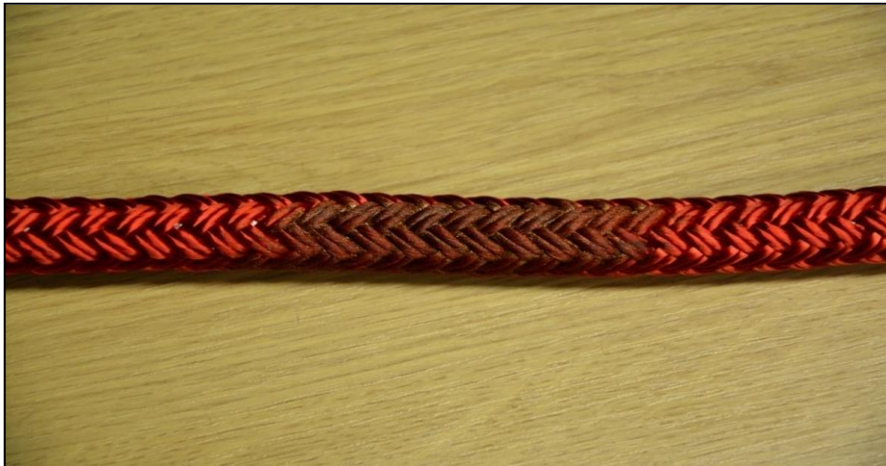
2.6 SOILING

Acceptable amount of spoilage, service may continue.

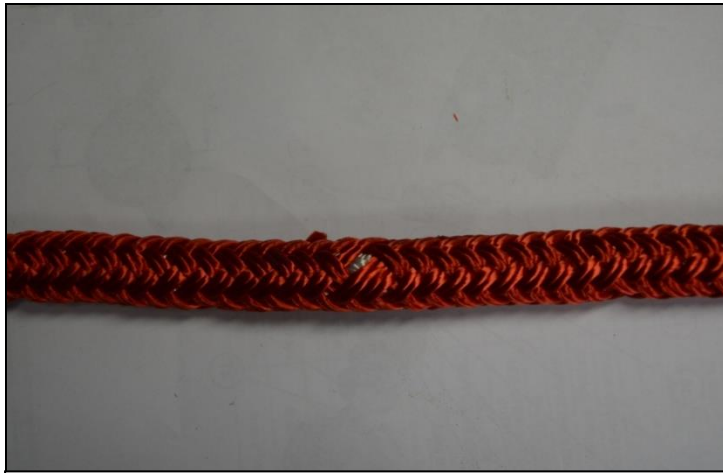
Acceptable amount of damage, service may continue.

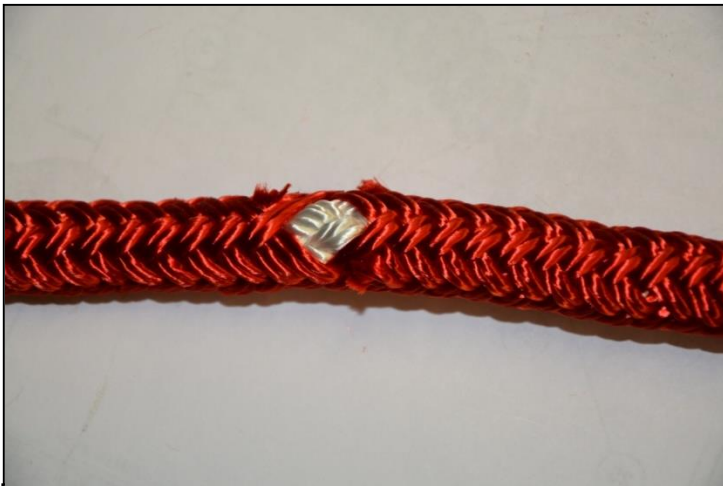
Unacceptable amount of damage, remove from service immediately.

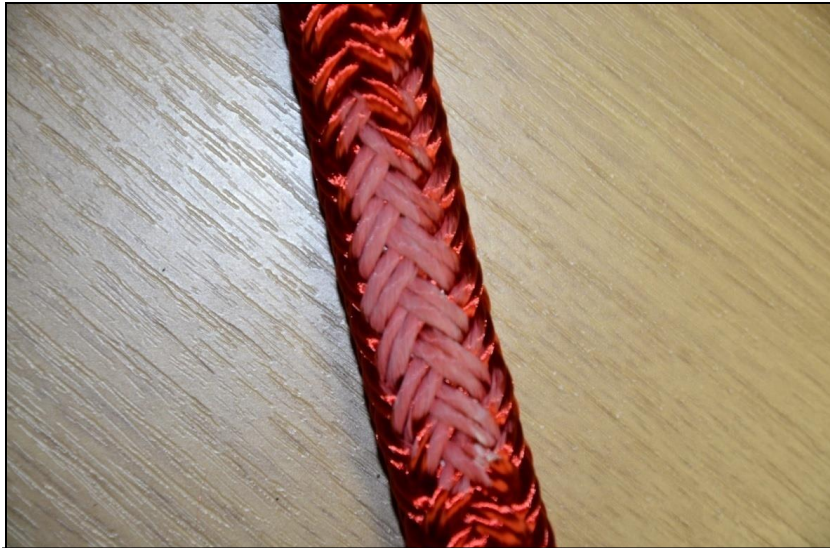
2.8 Paint

Acceptable amount of spoilage, service may continue.

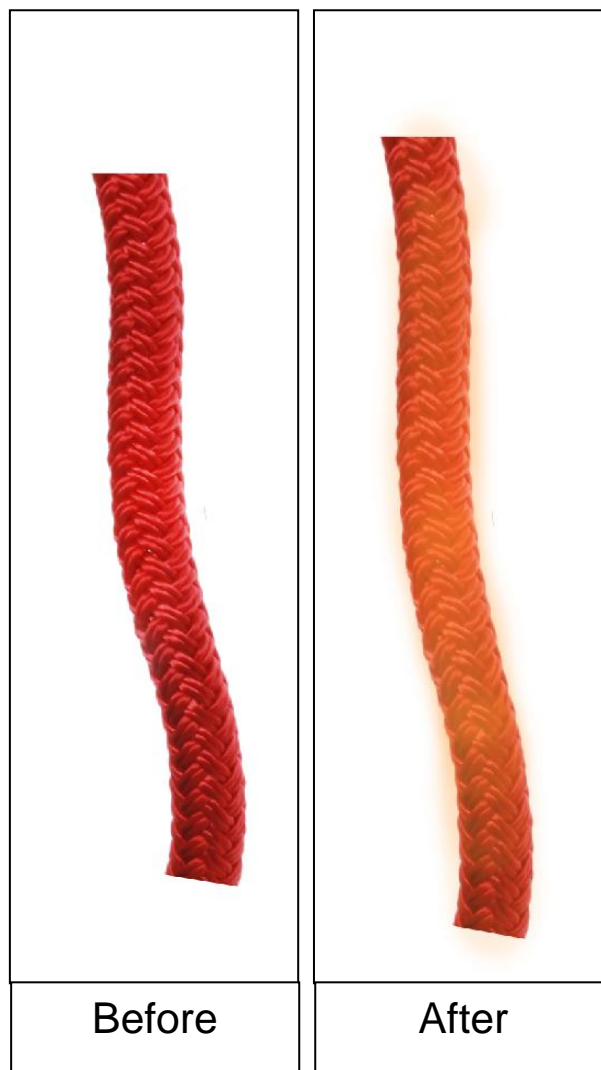
2.9 UV Degradation

Inspect the entire length of the lifeline for signs of UV damage such as the example below. If the rope look like the example given in the 2nd image remove from service immediately.
